Geometrical Design Errors in Duhok Intersections by Driver Behavior

In this study, two sites with large number of driving mistakes were noticed. One site is a roundabout within the university of Duhok campus. The other is the intersection just outside the University of Duhok eastern main gate. At both sites, the geometry is very confusing and encourage driving mistakes.

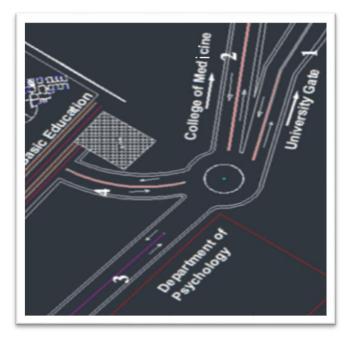
Figure (3) a close look on the roundabout

Figure (3) shows the detail plan of the roundabout. The inscribed circle diameter = 46m and central island diameter = 24m. Making a clear circulatory roadway = 11.1m or three lanes of 3.7m.

- 2- The roundabout has clear circulatory roadway of three lanes. According to the size of traffic, this is far from the need. Two lanes is quite enough.

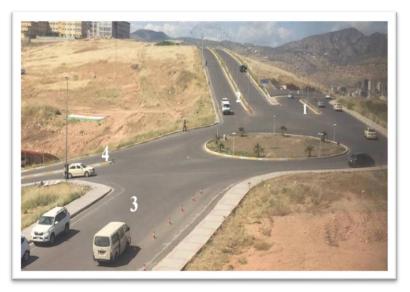
Figure (4) Photo of the roundabout taken from the department of psychology

Approach 2 from the college of medicine has a very steep slope, Figures (4) and (5). The slope towards the roundabout reaches 14%. Making it very difficult to break at the roundabout entrance. If driver inter the roundabout at a speed of 30 km/hr he needs about 40m to stop if break at the roundabout entrance. According to the AASHTO green book (AASHTO, 2011) "grades in excess of 3 percent should be avoided on the intersecting roads and where conditions make special designs too expensive, grades should not exceed about 6 percent. To reduce the speed on this approach a rubber hump was put at the entrance of this approach to the roundabout.

- 3- The roundabout is located at the end of steep slope of approach 2. Approach 2 has a 14% slope making it hard to stop at the required distance.
- 4- In the intersection near the eastern gate, drivers have to drive along distance around inappropriate badly designed divisional island. The island has a sharp small radius curve. Near the tip of this curve, the asphalt pavement is badly corrugated. These factors encourage drivers for wrong side move.

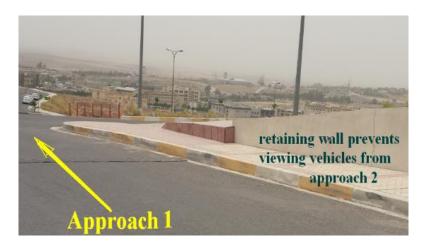
because of the high slope of approach 2 and the existing of a retaining wall, Figure (5), separating approach 1 and 2, no enough stooping sight distance is exist between vehicles approaching the roundabout from directions 1 and 2. The available stopping sight distance is about 16m, Figure (6), whereas the required stopping sight distance for a vehicle approaching from 1 at a speed of 30km/hr is 28m.

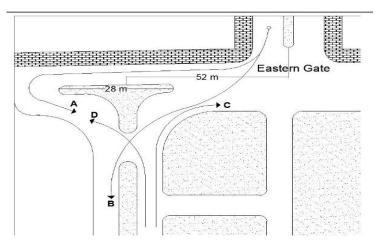
Figure (8) the intersection on the eastern gate

- 1- A large eccentric alignment between the university main gate and the main road. The (52) m eccentricity makes the traffic flow more difficult, create some congestion on the morning peak hour, and encourage wrong side driving.
- 2-Drivers exiting the university main gate toward the main road have to move around (28) m divisional island, direction (A), Figure (8) before entering the main road. This encourage wrong side driving in (B) direction.
- 3- Drivers heading for the university cultural center from the main road should rotate around the (28) m divisional island in a sharp curve. This will encourage wrong side driving in direction (D)

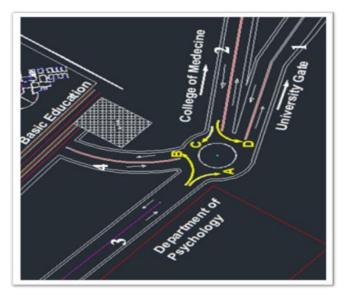
Figure (10) Observed wrong side movements, B and D

As previously mentioned the geometry of the roundabout encourage wrong side movement. The large circulatory roadway and the lack of proper divisional islands increase wander space. Giving the driver a thought that it is a large open pavement area and not a roundabout. Figure (10) shows the observed wrong side movements: B, and D.

The first was approach (3) from the department of psychology. This was split in two streams: the right path A around the roundabout and the wrong B towards the basic education college.

The second was approach (2) from the college of medicine. This was split in two streams: the right path C around the roundabout and the wrong D towards the main gate.
