Slope Stability Evaluation of Euphrates Out Crops at Najaf Governorate-Center of Iraq: Analysis Study

In this study the stability of the rock has been evaluated to determine the most relevant factors affecting instability of slope. The discontinuity data collected from the field surveys was analyzed using stereograph projection. Sub horizontal-layer slopes of limestone rocks in Euphrates formation at Al-Najaf governorate, center of Iraq, presence of failures in slopes, Its from most to least rock fall, secondary toppling, and rolling. The degree and nature of hazard risk depend on properties of the rock discontinuity. This study recommends that rock instability is enhanced by fences barrier and building concrete walls and remove weak rocks.

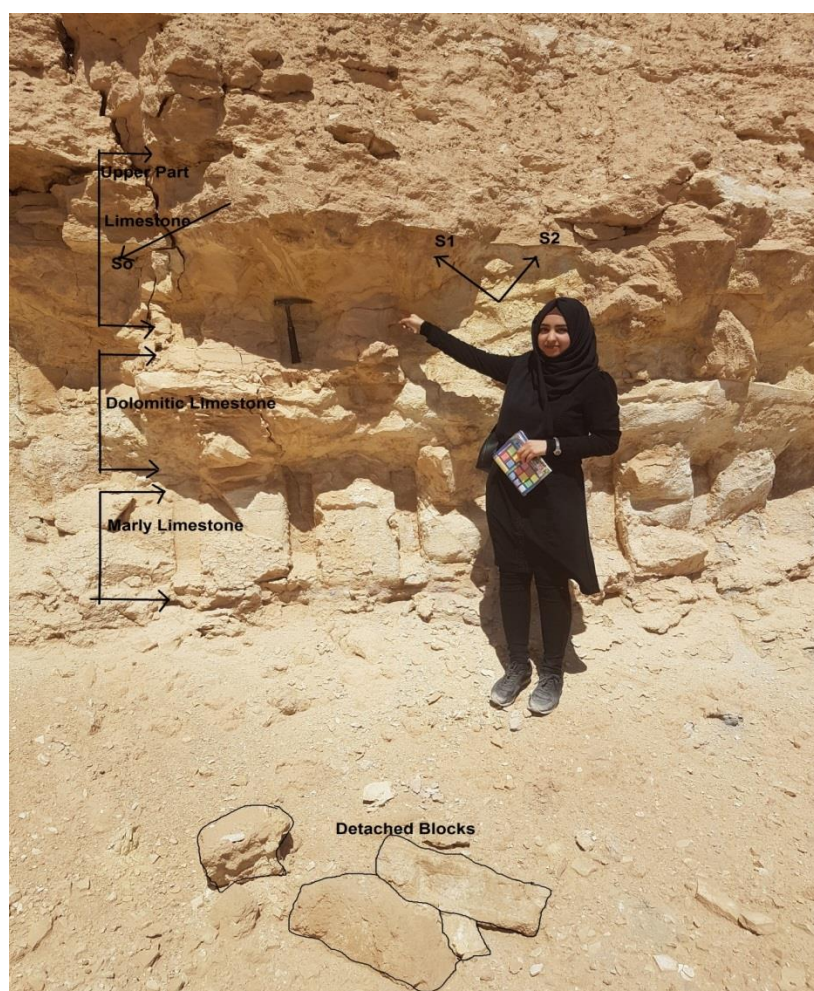
picture 2: slope and discontinuities of S(2), photo direction NE

S.2: The Euphrates outcrops are located at latitude ($31^{\circ} 50' 3.248''$ N) and longitude ($44^{\circ} 14' 14.771''$ E) (picture 2). The slope is 6 meters high, 15 meters long, and 320 degrees inclined. Because the average dip layer is $170/04^{\circ}$, it has a subhorizontal – layer slope. A 3 m thick stratum is exposed at the top of the hill. They are LIMESTONE ($c = 38$ MPa), pale green, thick bedded, and moderately strong

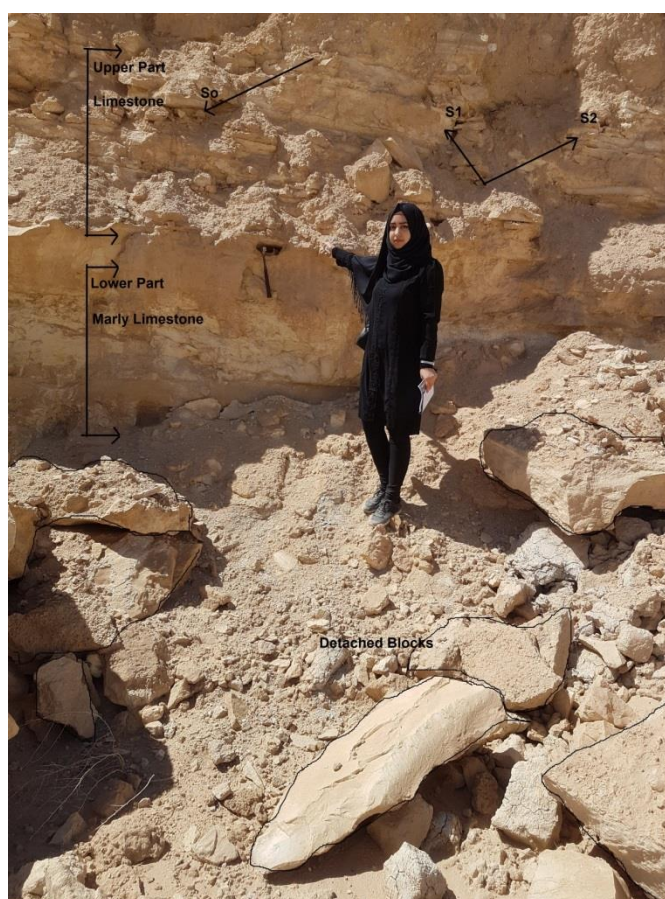
picture 4: The discontinuities and the slope of (S4), direction photo SW

S.4: The Euphrates outcrops are located at latitude ($31^{\circ} 51' 4''$ N) and longitude ($44^{\circ} 15' 15''$ E) (picture 4). The slope is 5 meters high, 20 meters long, and sloped at $260/84$ degrees. The average dip layer slope is $250/02$, making it a subhorizontal – layer slope. A 2 m thick stratum is exposed at the top of the slope. They are LIMESTONE medium strong ($c = 32$ MPa), pale green, deeply bedded, and severely worn. The underlying rock strata in the lowest of the slope are 3 meters thick. MARLY LIMESTONE is light grayish, deeply bedded.
