Geometrical Design Errors in Duhok Intersections by Driver Behavior

In this study, two sites with large number of driving mistakes were noticed. One site is a roundabout within the university of Duhok campus. The other is the intersection just outside the University of Duhok eastern main gate. At both sites, the geometry is very confusing and encourage driving mistakes.

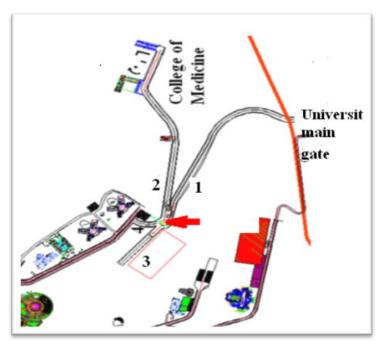
Figure (2) the location of the roundabout

Figure (2) shows the location of the first site, the roundabout near the department of psychology. The roundabout have four approaches. Approaches 1 and 4 are the major roads connecting the university gate to the whole campus. Approaches 2 and 3 are the minor with the lowest in flow and density as they end at the college of medicine and the department of psychology respectively.

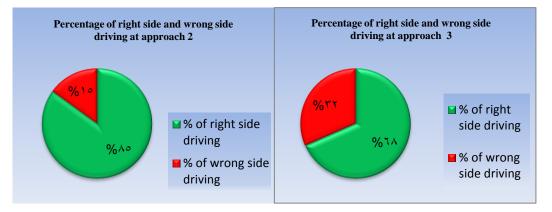
Figure (11) Percentages of right side and wrong side driving on approaches 2 and 3

Table (1) list the count during the peak hour at the roundabout **a** total of 226 vehicles were observed on approach 2 and 171 on approach 3. As shown from table (1) and Figure (11), there is 15% and 32% wrong side driving on approaches 2 and 3 respectively.

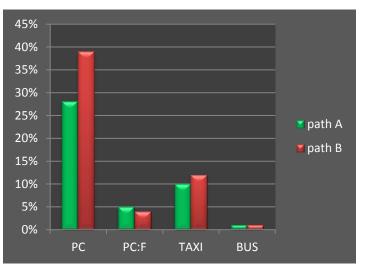
Figure (17) Vehicle categories in right and wrong paths

Figure (17) shows that there is no significant difference in road user's categories in the right and wrong paths except for the passenger cars. 28% of the total vehicles emerging from the main gate go in direction A, whereas 39% go in the wrong direction.

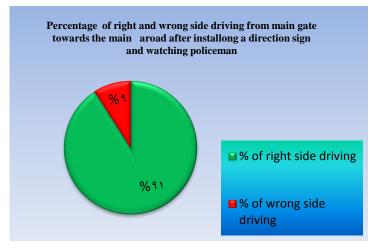
Figure (22) a large reduction in wrong side driving was achieved as a result of having direction sign and standing policeman
